Cuyama Basin – North Fork Vineyard

Company Background plus Data Insights to
Support GSP Development for the Cuyama
Basin

*Presented by Grapevine Capital Partners and Cleath-Harris Geologists
April 26th, 2018*

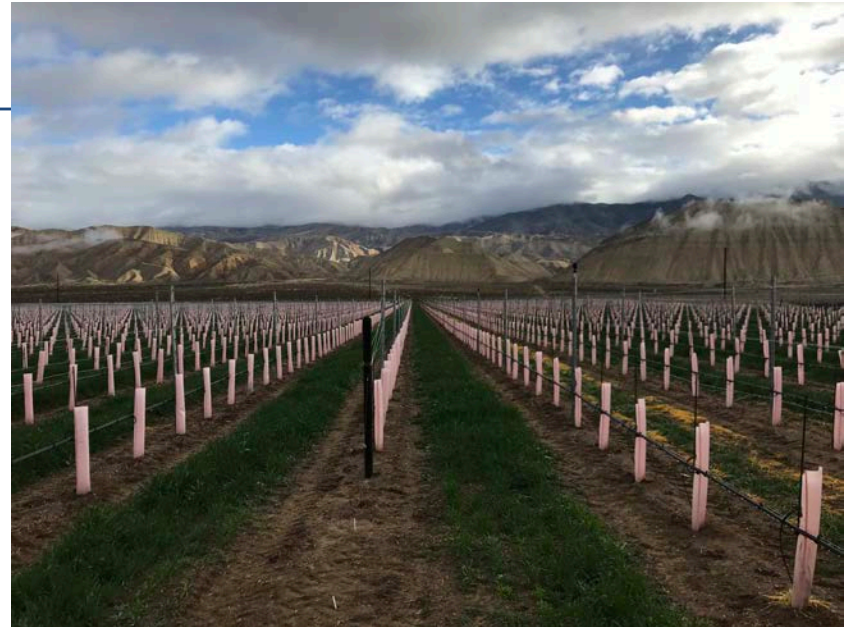
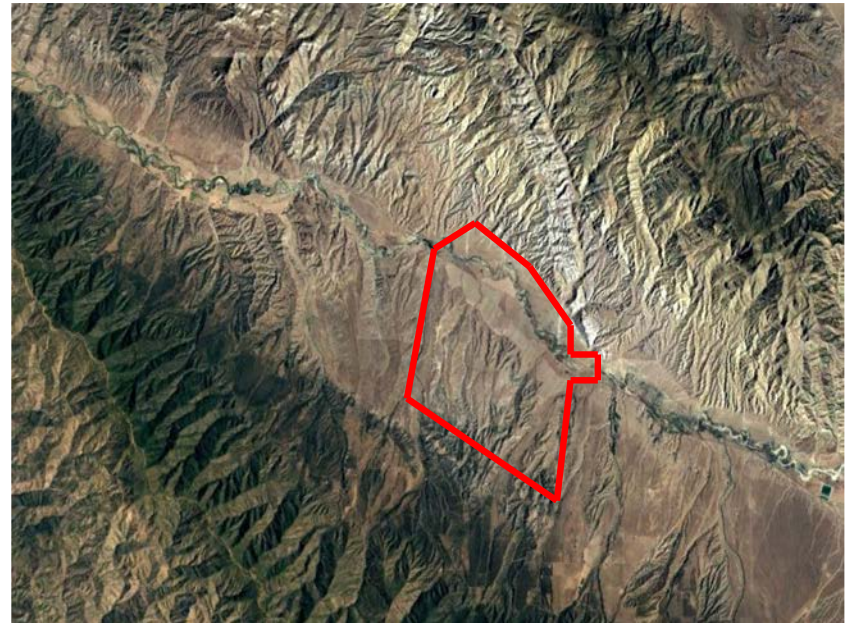
- North Fork will produce high quality grapes for Santa Barbara AVA wines
- The vineyard is designed for the climate and soil in the west end of the valley, including:
 - Variety and rootstock selection
 - Block organization and structure
 - Irrigation and frost protection
- We planted 850 acres based on our assessment of the local aquifer and its estimated annual recharge
- The total property is 8700 acres and spans most of the valley immediately west of the Russell Fault, and resides in San Luis Obispo and Santa Barbara Counties

Property lines are drawn approximately

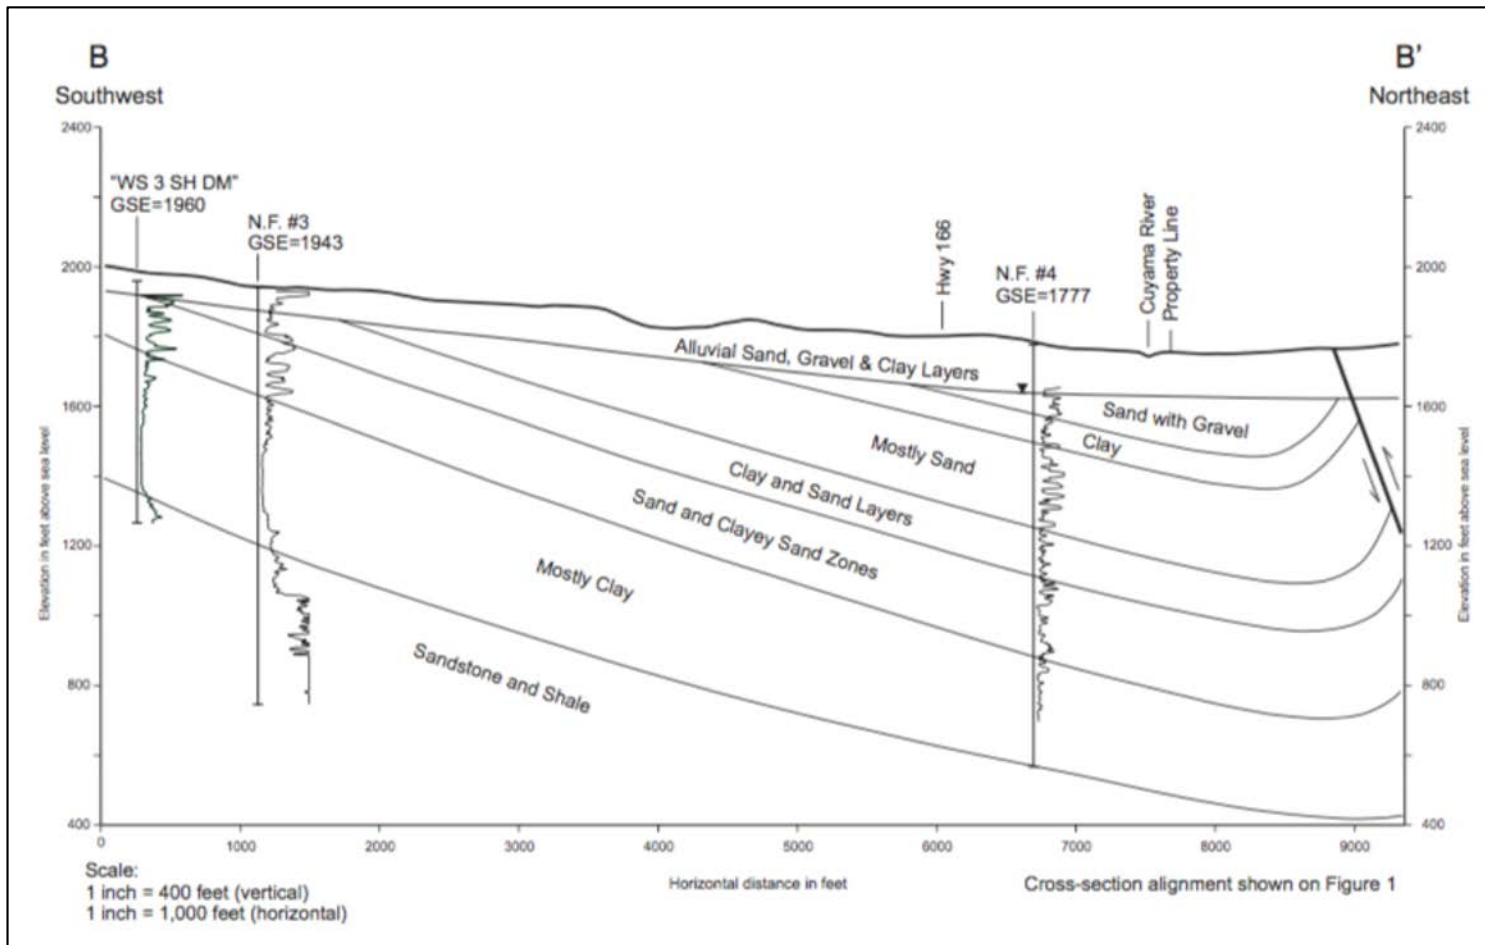
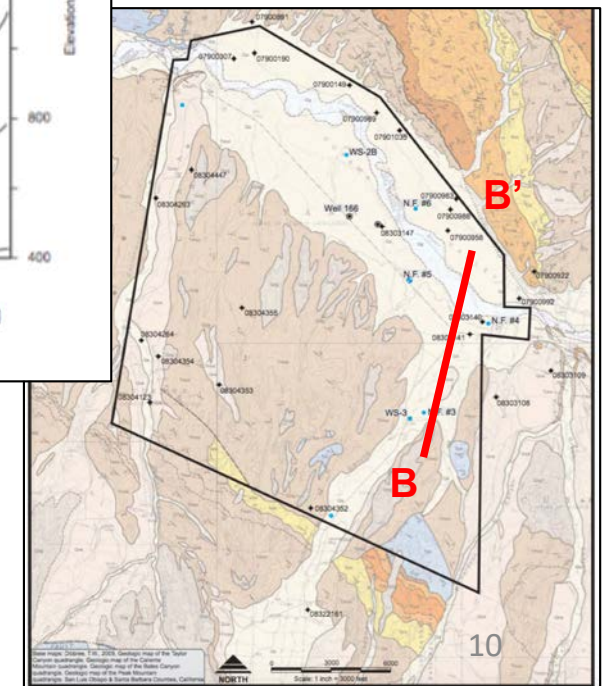
Early exploration showed a structural basin which deepens on the north-east corner of the property

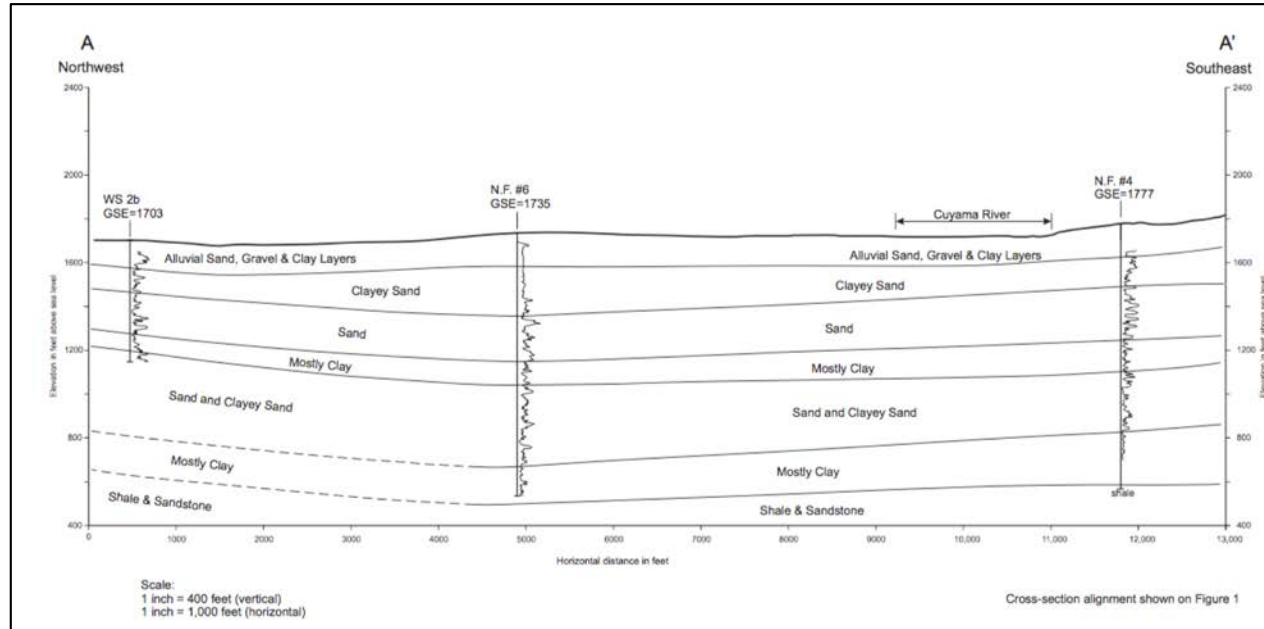
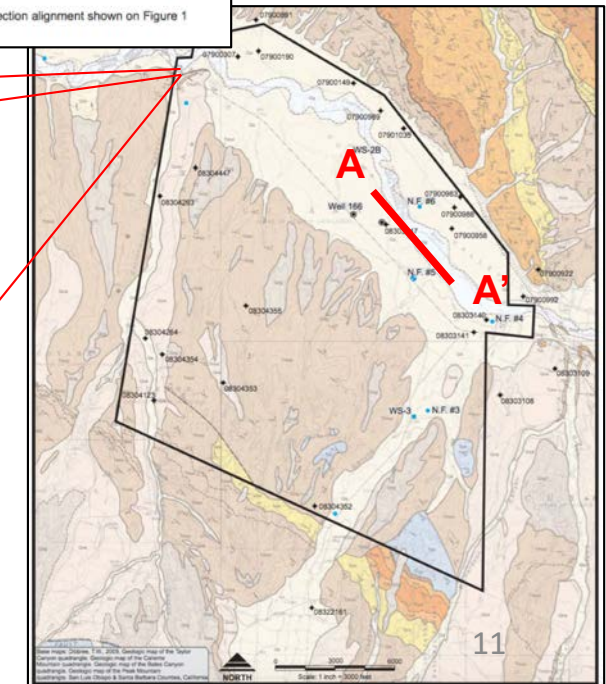
The deep deposits in the northeast corner of the property are truncated by the Russell fault to the east and by a structural high to the west

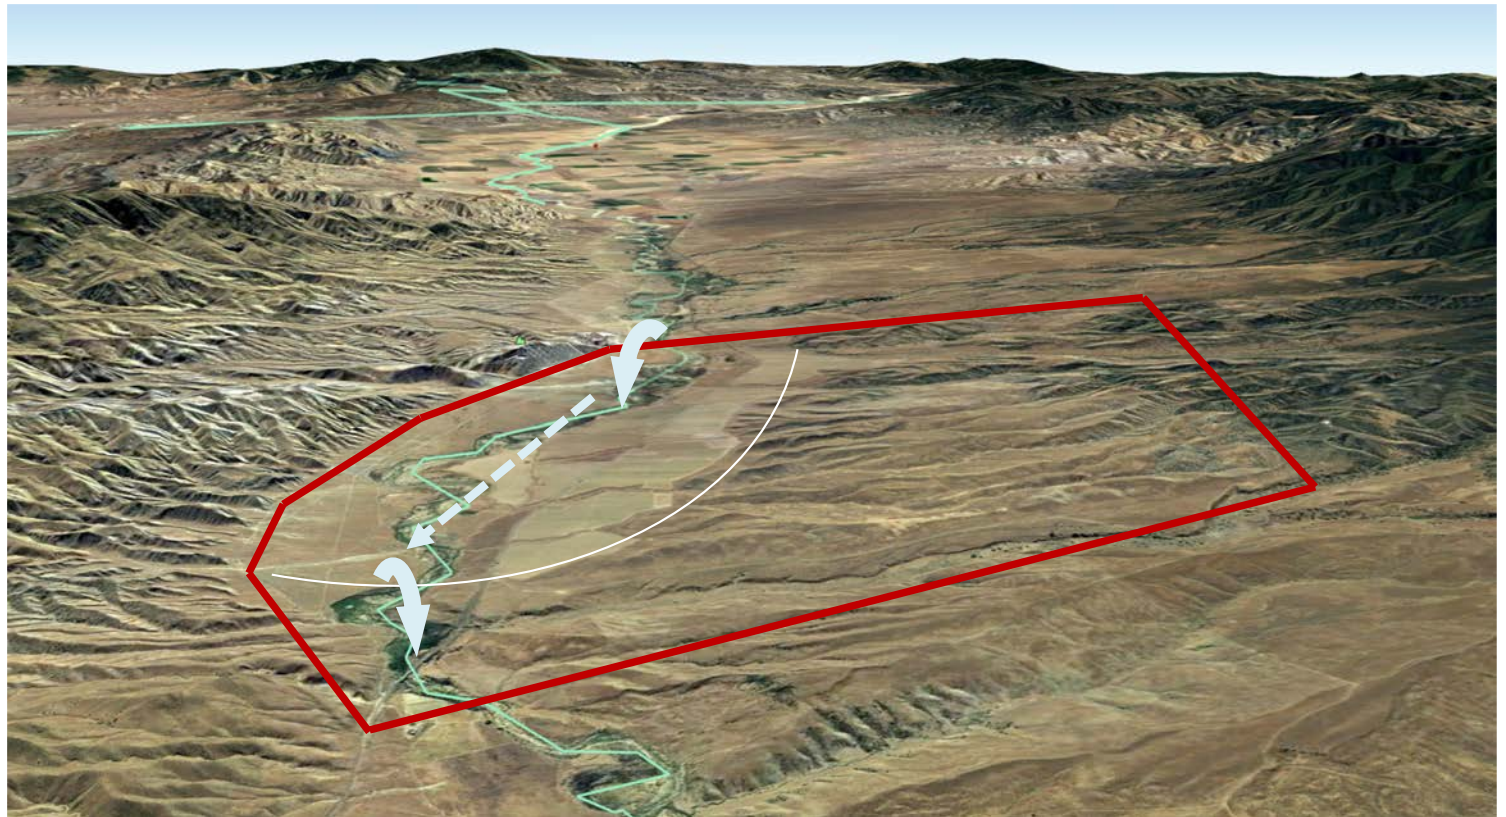
The vineyard's aquifer is in the northeast corner of the property

- The useful aquifer is immediately west of the Russell fault and ends were the river resurfaces on the west corner of the property.
- Primary recharge is from surface flow
- The depth and sediment composition enable recharge during river flow events

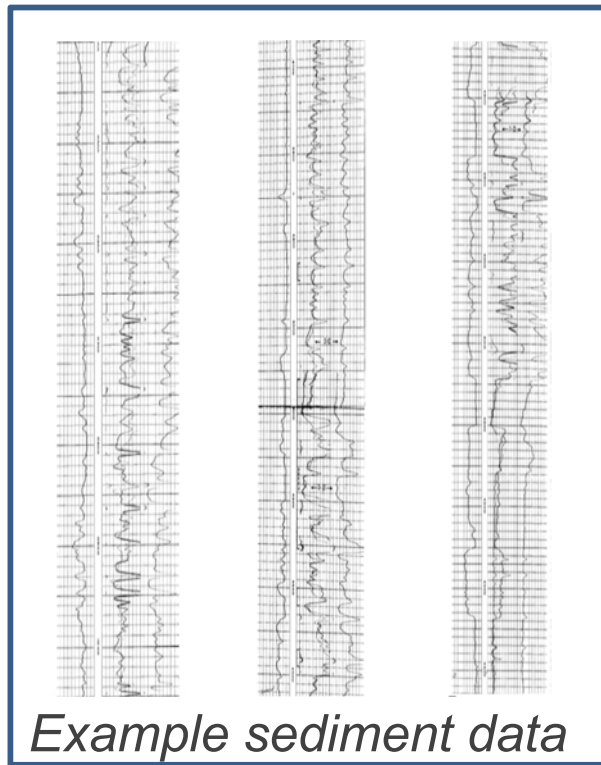
CHG analyzed oil well data on both side of the fault and drilled additional test holes on the west side

Test hole data provide a cross sectional view geological formations across the fault.

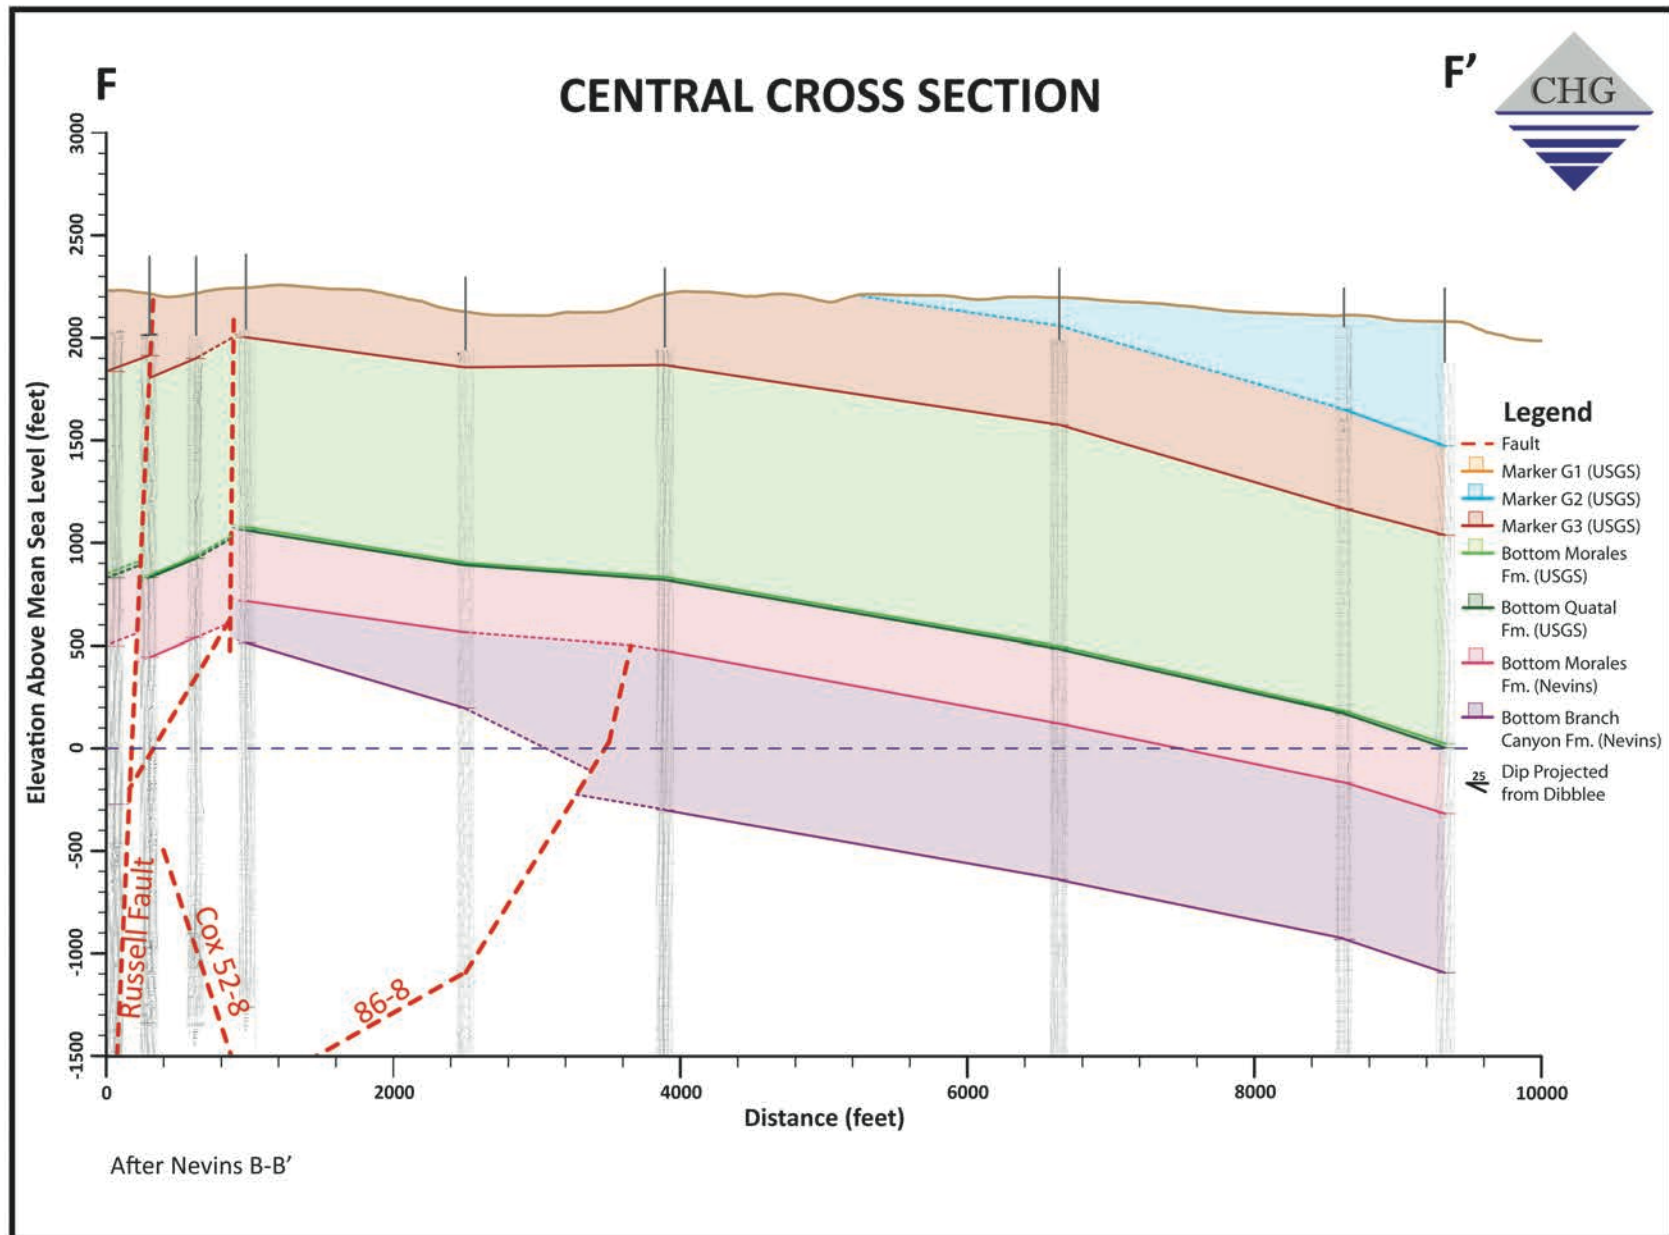
Other cross sections demonstrate the plane of failure across the Russell fault

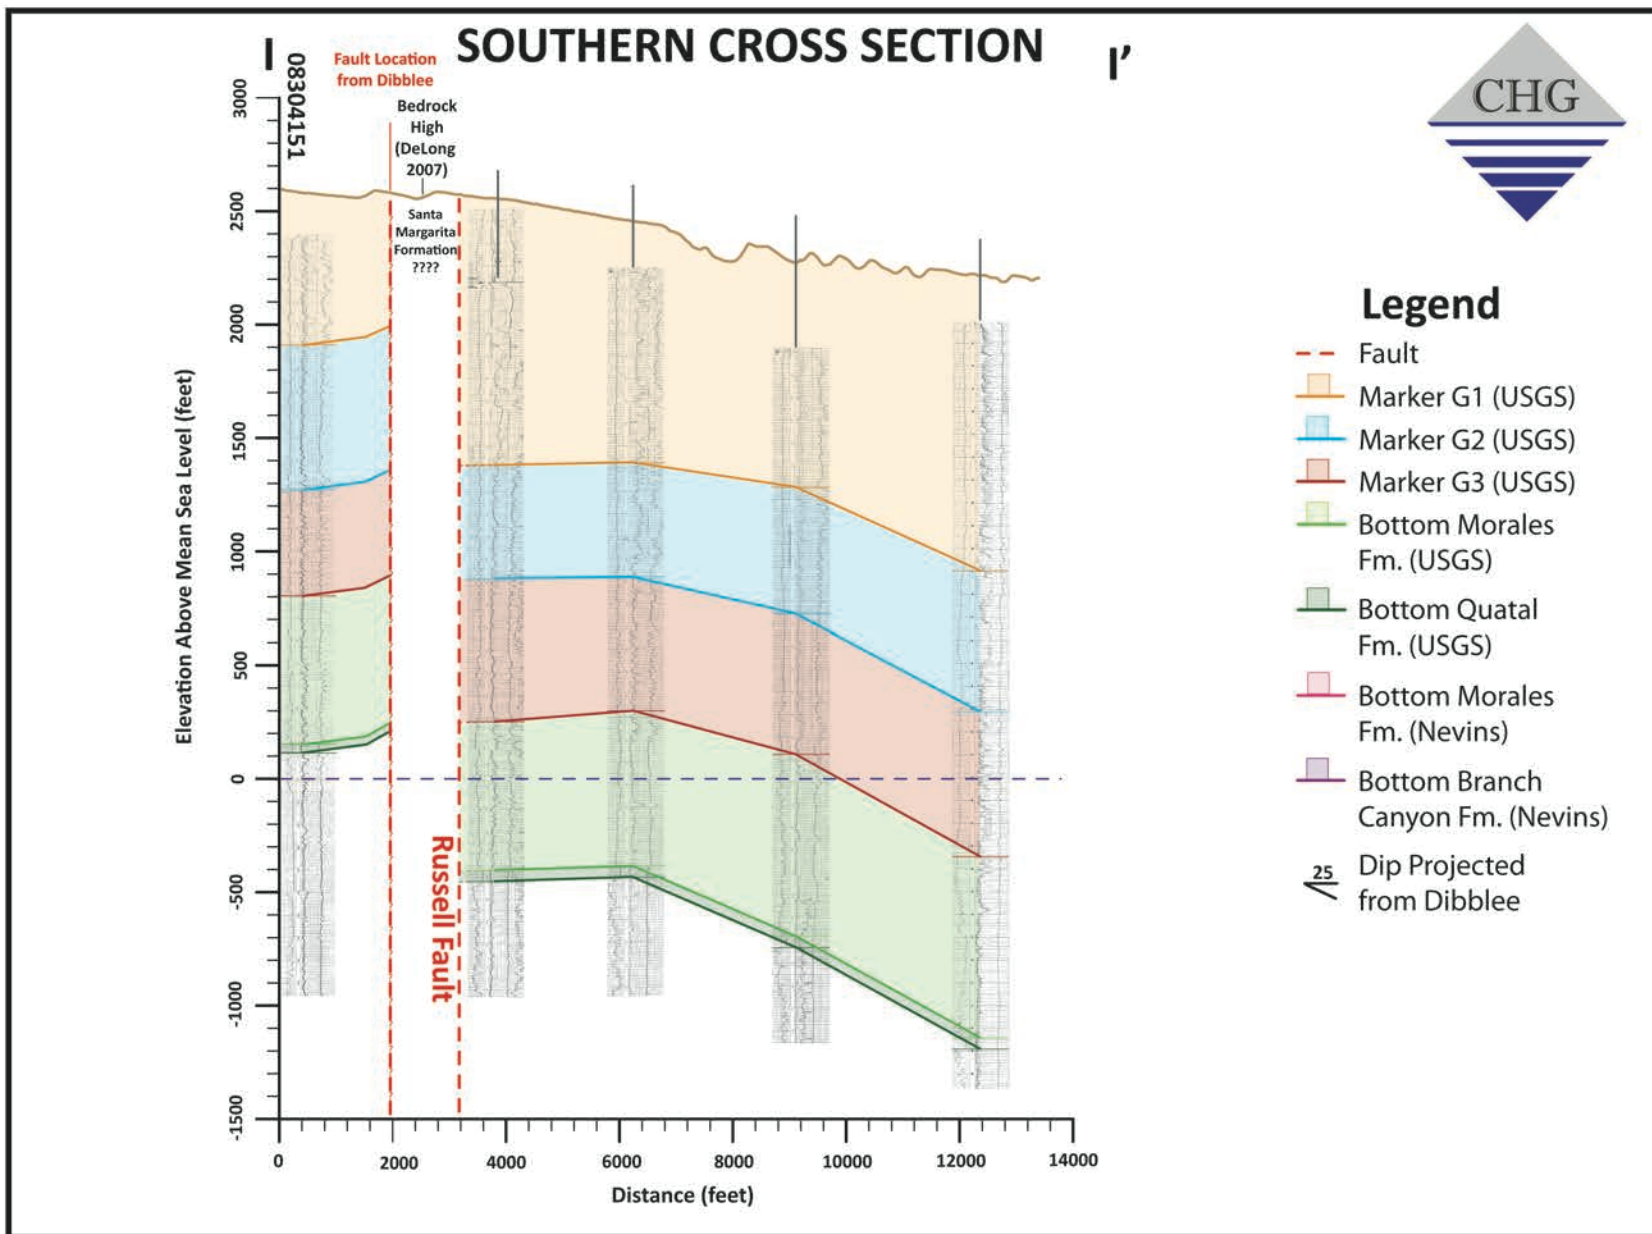
Offsets in the Morales at section I-I' exceed 500 feet

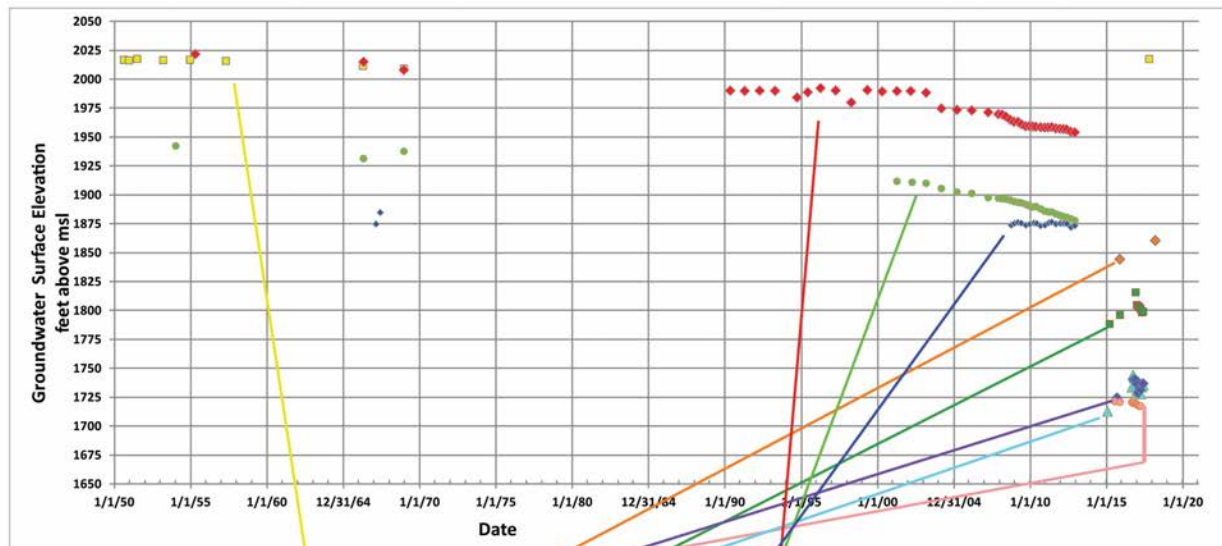
Water levels at the fault have remained stable since the 1950s

When measured last month by USGS, our well levels were 40-60 feet below the ground level

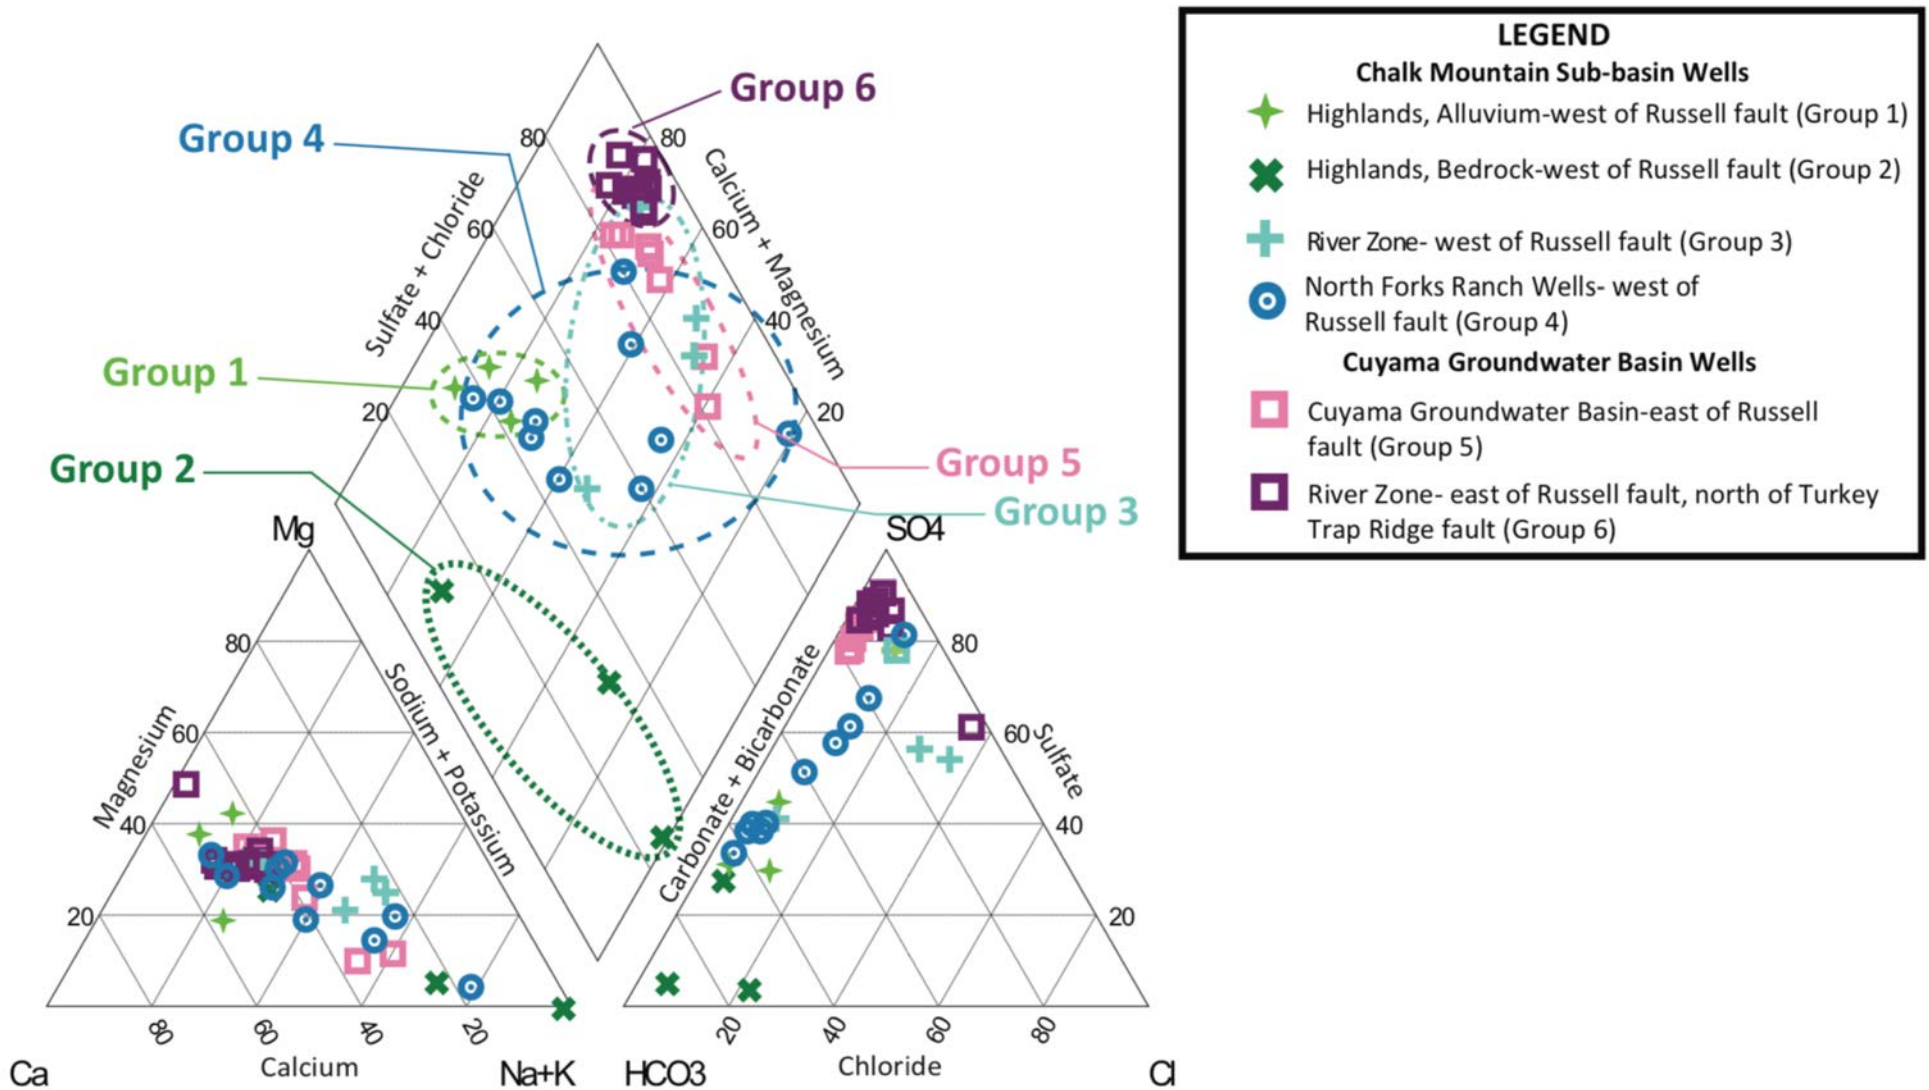
Water quality east and west of the fault are noticeably different by mineral

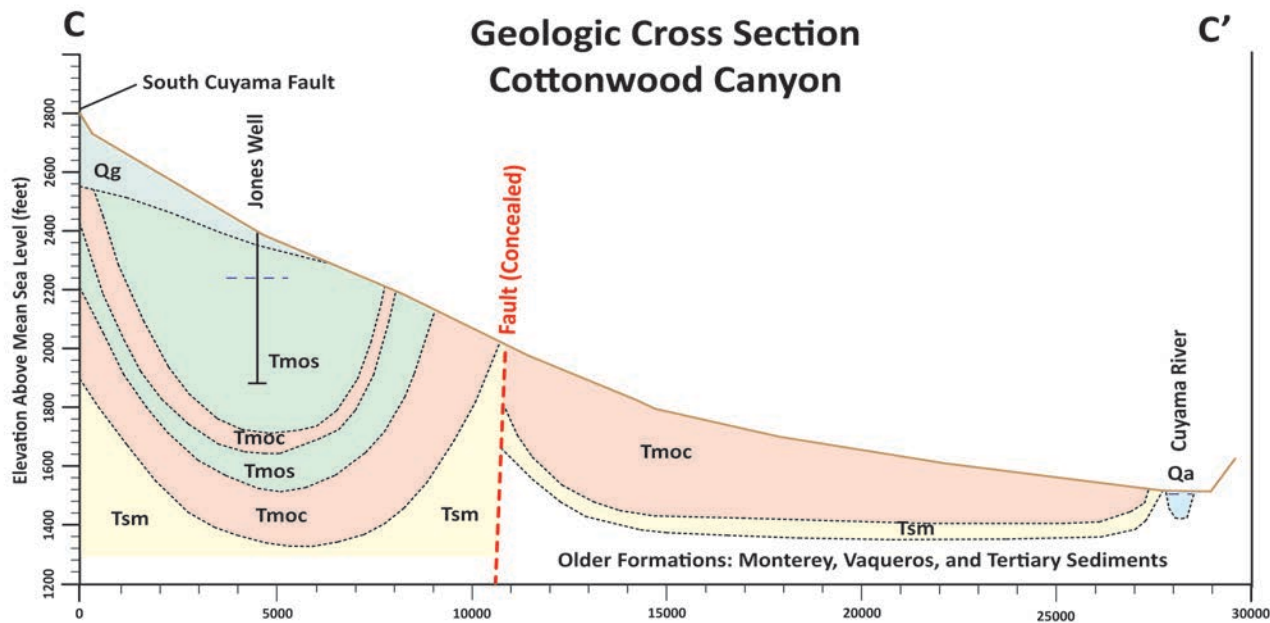
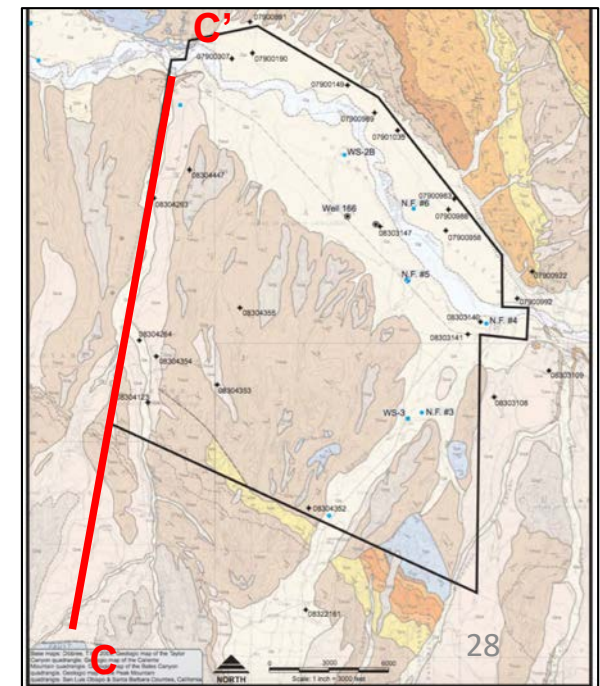
We have heard misconceptions that our pumping is effecting residential wells up Cottonwood Canyon

- The upper basin in Cottonwood Canyon is separated from our downhill aquifer by a fault on the south end of our property.
- Bedrock formations at the fault dip to the south at 60deg angles and are visible from Cottonwood Canyon Road.
- The water levels of our production wells are ~500 ft below water levels in this community. If the aquifers were connected it would result in over 200 psi pressure at our end, which is not the case.

- Qa: alluvium
- Qg: fan gravels
- Tmos: Morales- sands and clays
- Tmoc: Morales- clays
- Tsm: Santa Margarita Sandstone
- - - water level

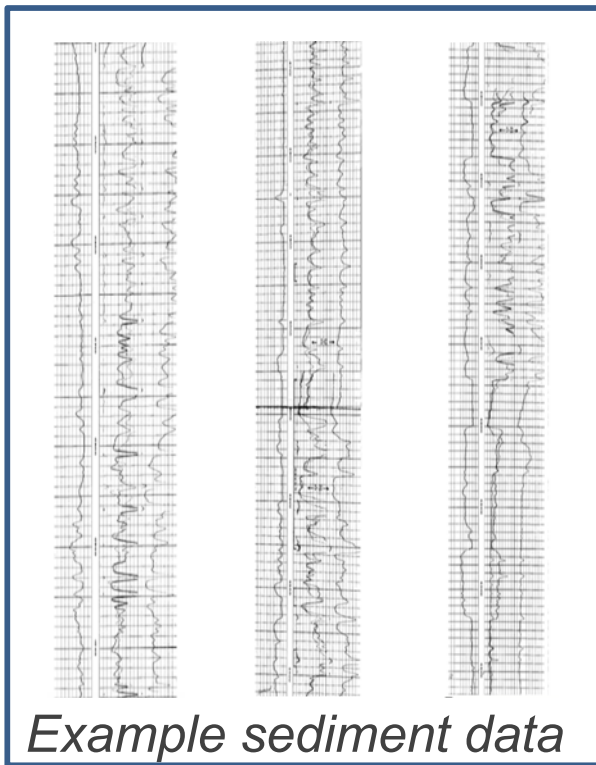
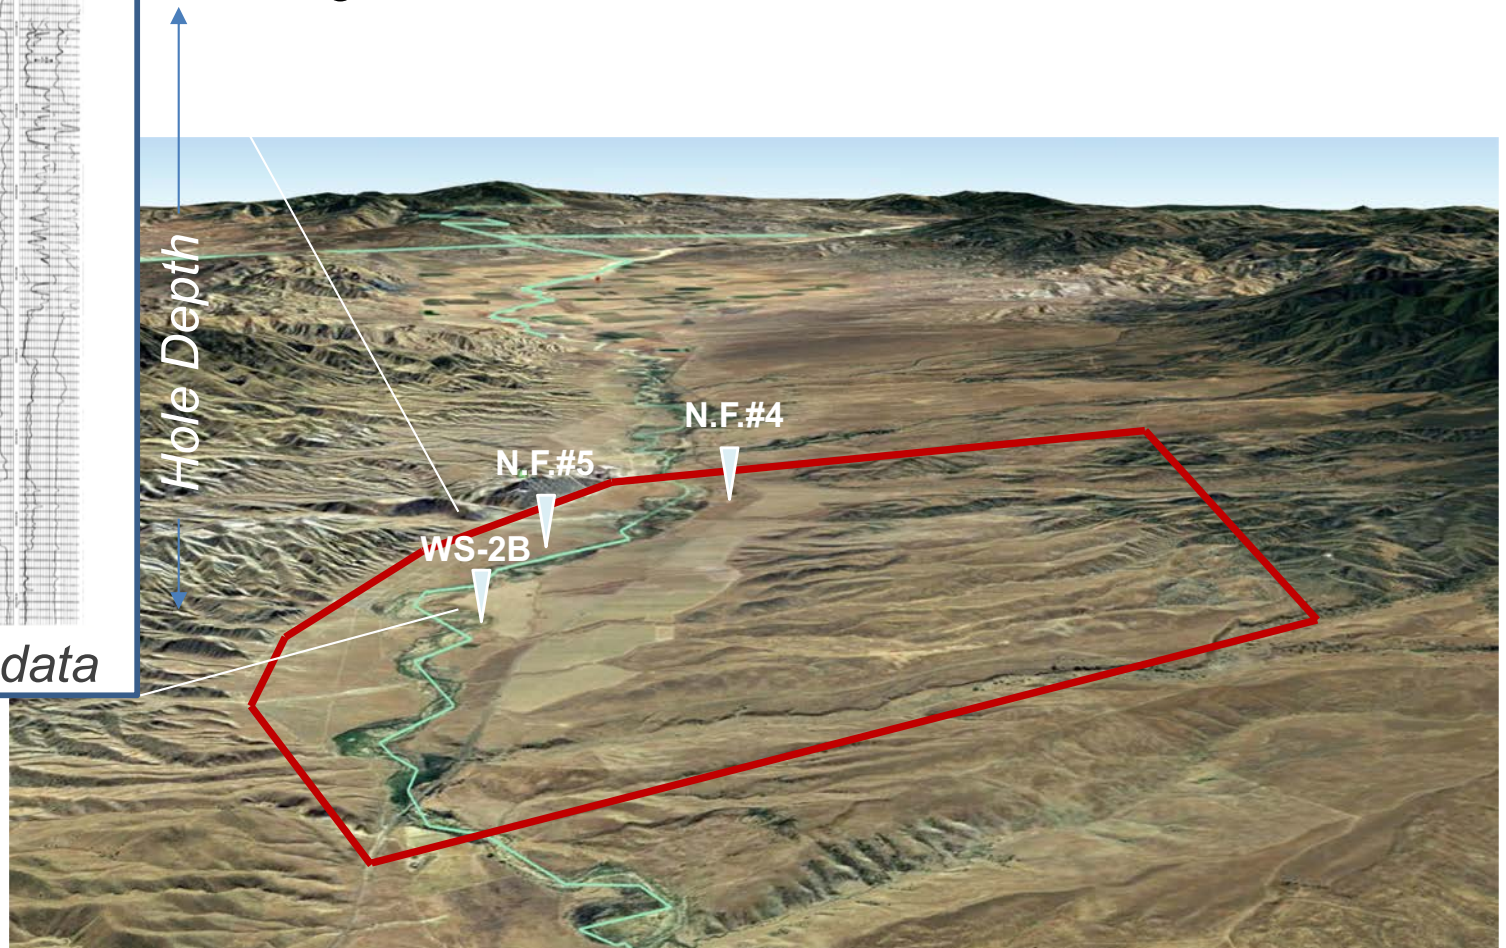
Well drilling logs tell us accurate details of sub-surface sediment layers

- Well casings are perforated where productive water is available and blocked above and below target zones

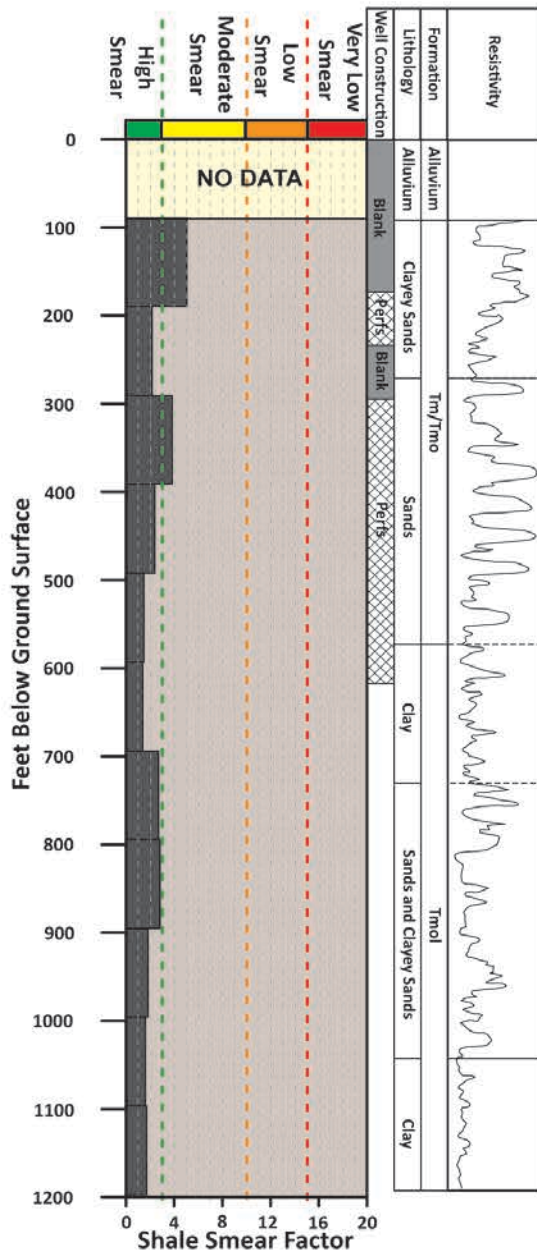
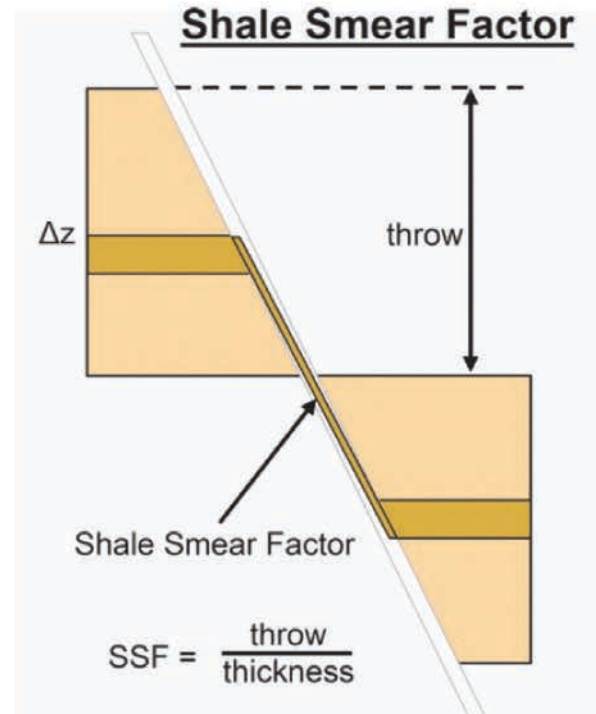
Additional analyses were conducted to estimate clay smearing across the fault

SSF Calculated using NF #4 Well Log and 100' of fault offset

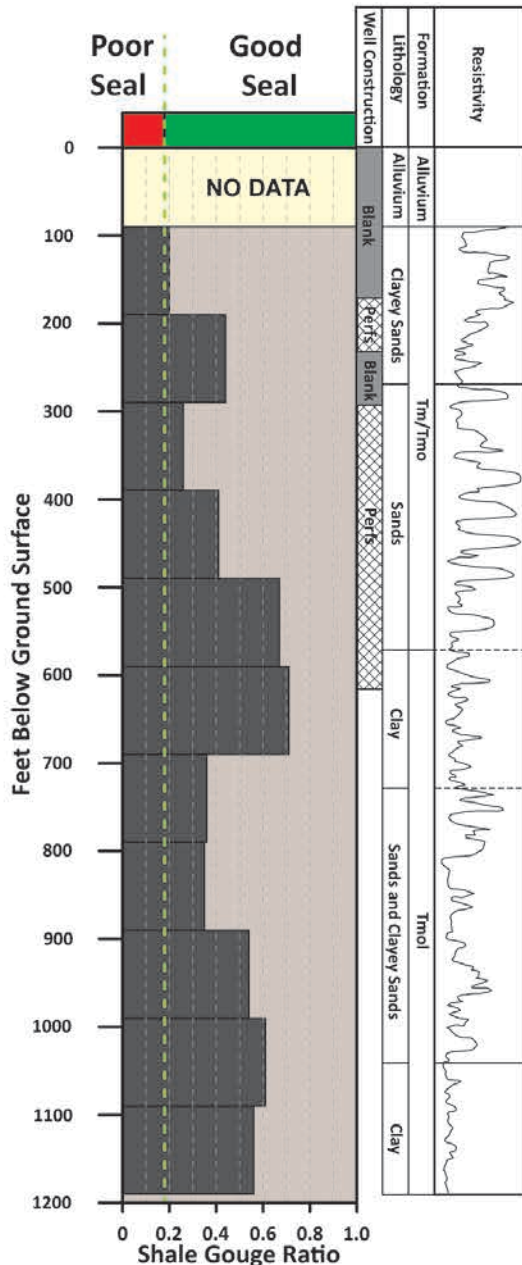
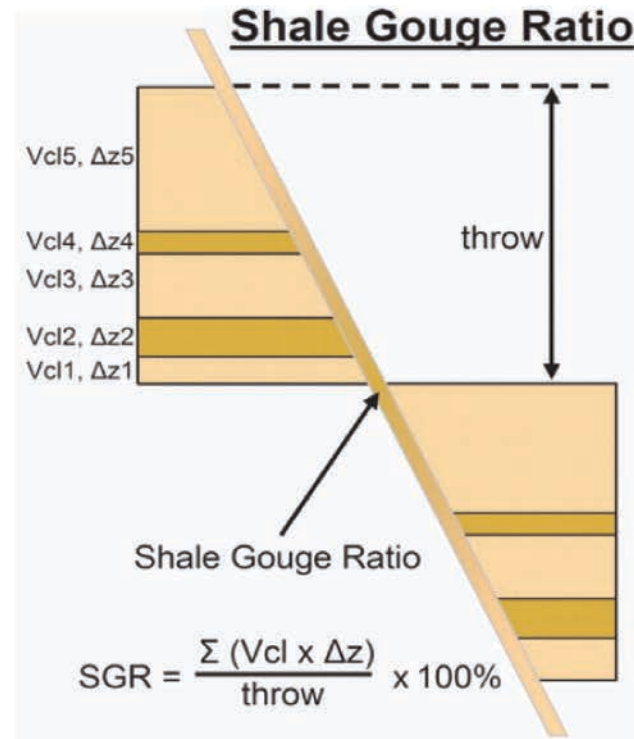
Shale gouge ratio and shale smear factor both demonstrate a good seal on the fault

SGR Calculated using NF #4 Well Log and 100' of fault offset

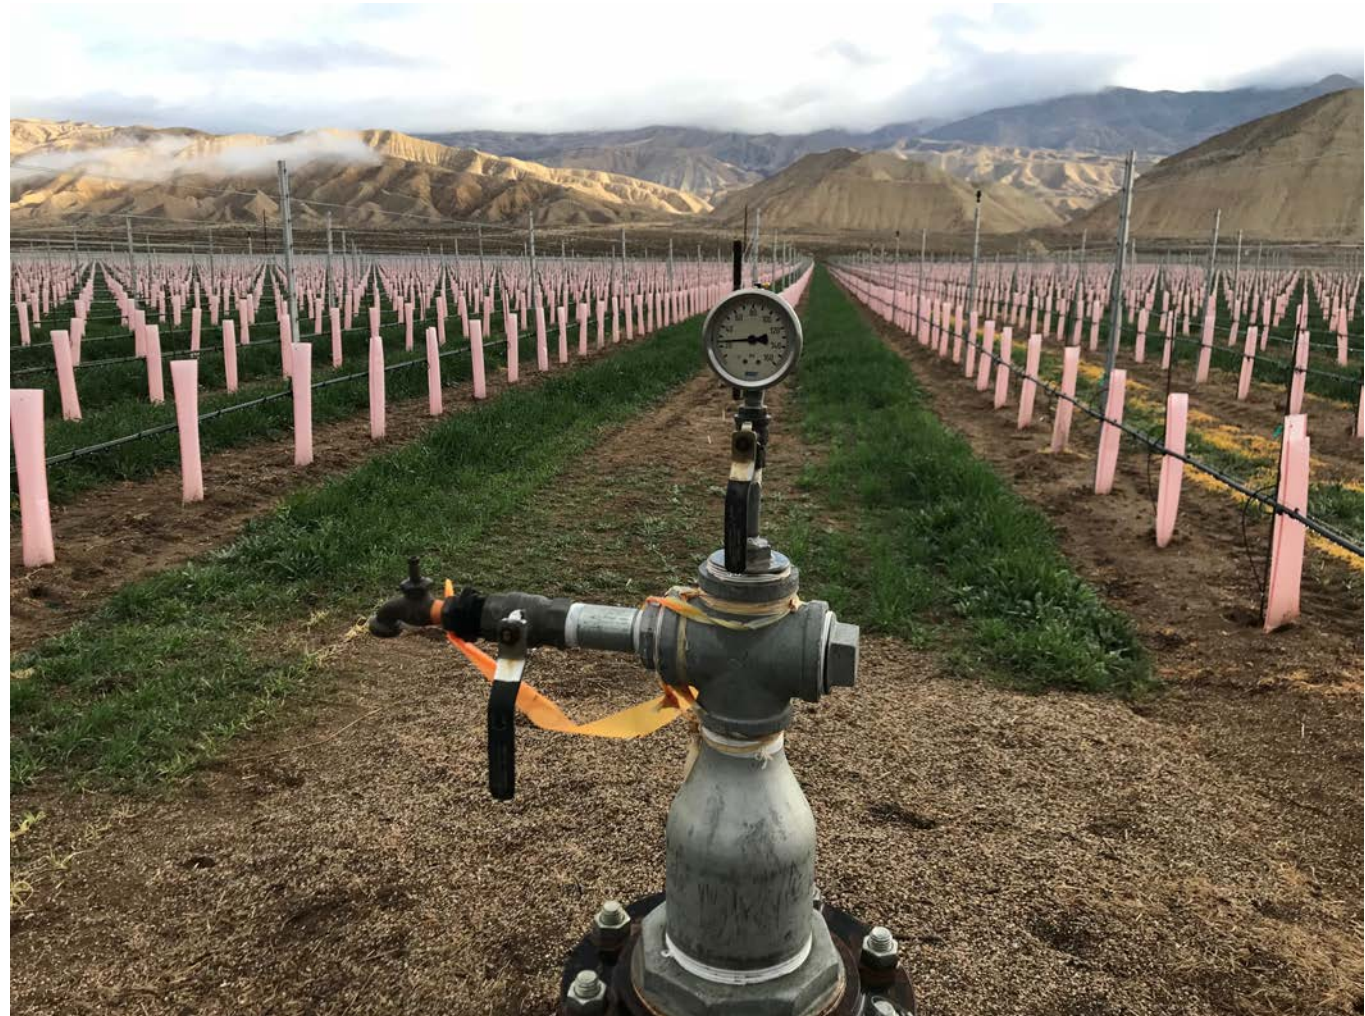
A unique but telling feature on our property is an artesian well with ~25psi static pressure

- This well is on the east end of our property, in line with the cattle corral up-hill to the south
- Pressure has increased 10 psi since drilling
- Like the other wells, drilling logs are available
